## **TEST REPORT**

### **ref. No. 412503666-01**

**Sample:** Exterior Grade laminate - "Greenlam & Mikasa "

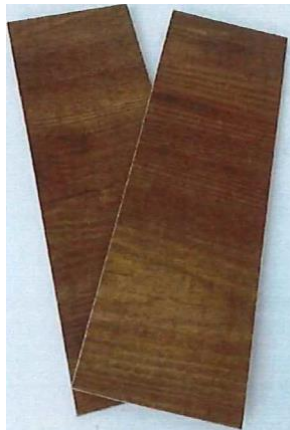
| ITC's identification number | Sample identification by client | Description of submitted sample |
|---|---|---|
| 412503666/1 | Exterior Grade laminate - "Greenlam & Mikasa" | Pieces of Compact laminate |

**Fig. I - Exterior Grade laminate - "Greenlam & Mikasa"**
